U.S. CHEMICAL SAFETY AND HAZARD INVESTIGATION BOARD

INVESTIGATION REPORT

XCEL ENERGY HYDROELECTRIC PLANT

PENSTOCK FIRE

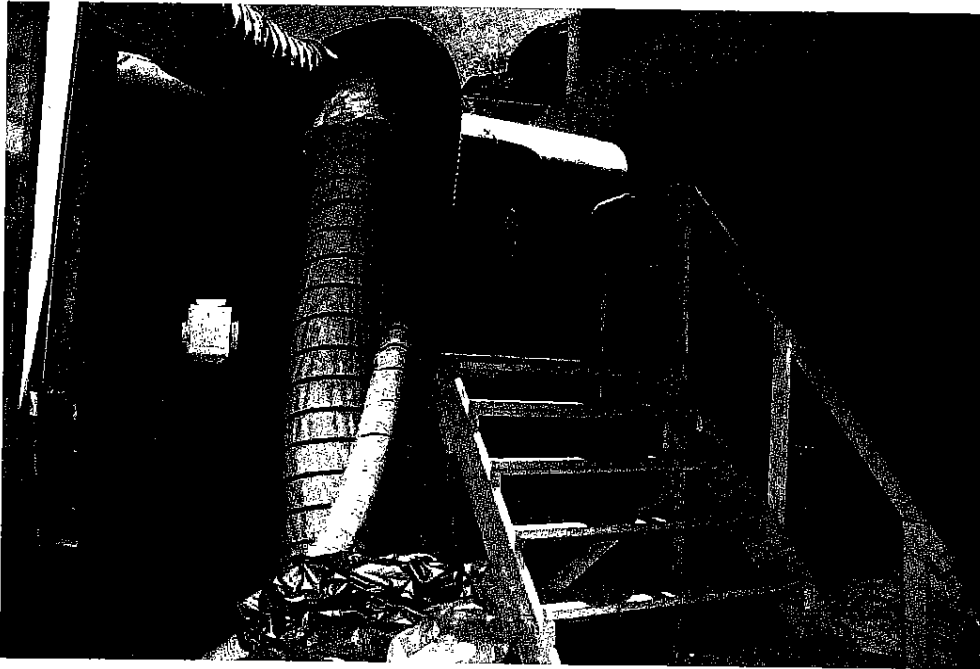
Figure 3. Access door cut into penstock for recoating work

¹² The access opening was cut by a specialty welding contractor; Xcel Energy was unable to provide the hot work permit for this work to the CSB.

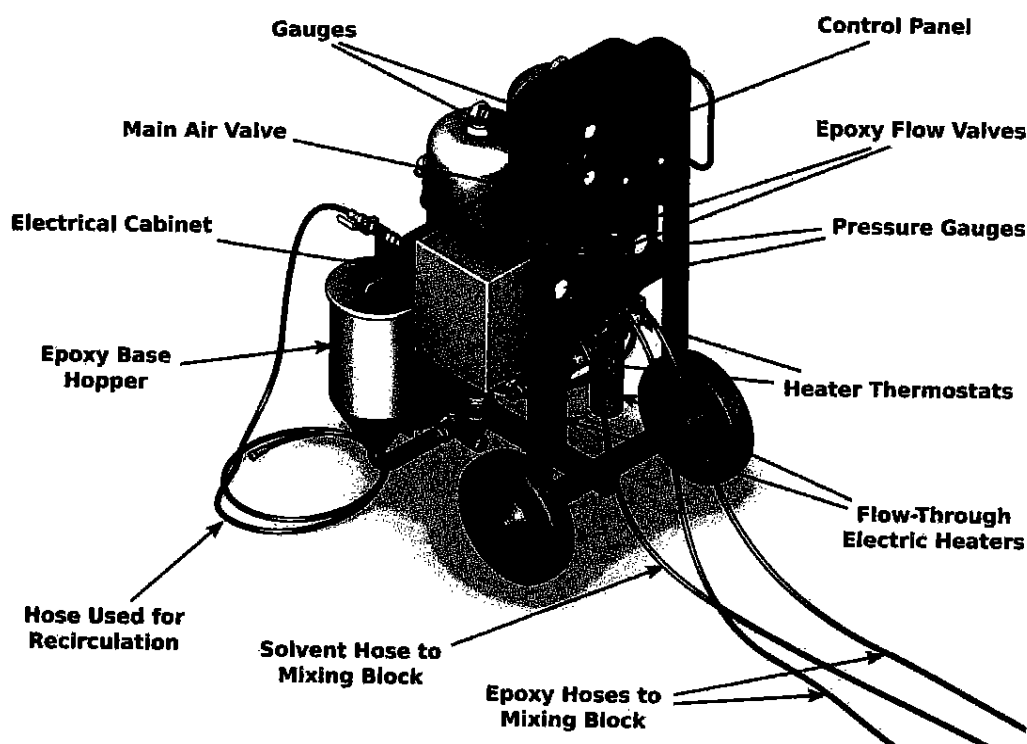
Figure 4 The epoxy sprayer system used within the penstock

The sprayer, a plural component (two-part) epoxy spraying system manufactured by Graco, is typically used in industrial epoxy application projects (Figure 4).

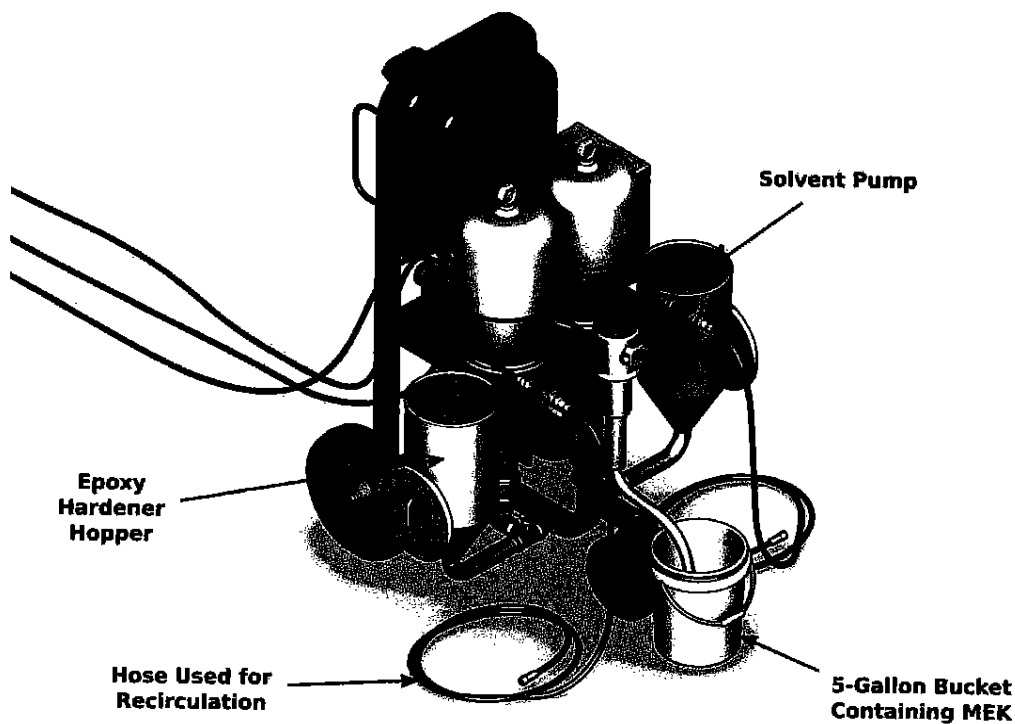
Figure 5. The solvent pump on the back side of the epoxy sprayer

Solvent, such as methyl ethyl ketone (MEK), is needed if problems arise when applying the epoxy mixture. If the combined epoxy product was to set, it would harden within the hoses and spray wands, ruining the equipment. Solvent would be used to flush out the mixing block and hoses to the spray wands to ensure that the epoxy mixture was fully removed from the equipment and would not permanently render it unusable. Solvent would be introduced into these portions of the spray system using a third smaller pump situated at the back of the machine that would take in solvent from a bucket placed on the ground at the back of the sprayer (Figure 5). A hose ran directly from this pump to the mixing block.

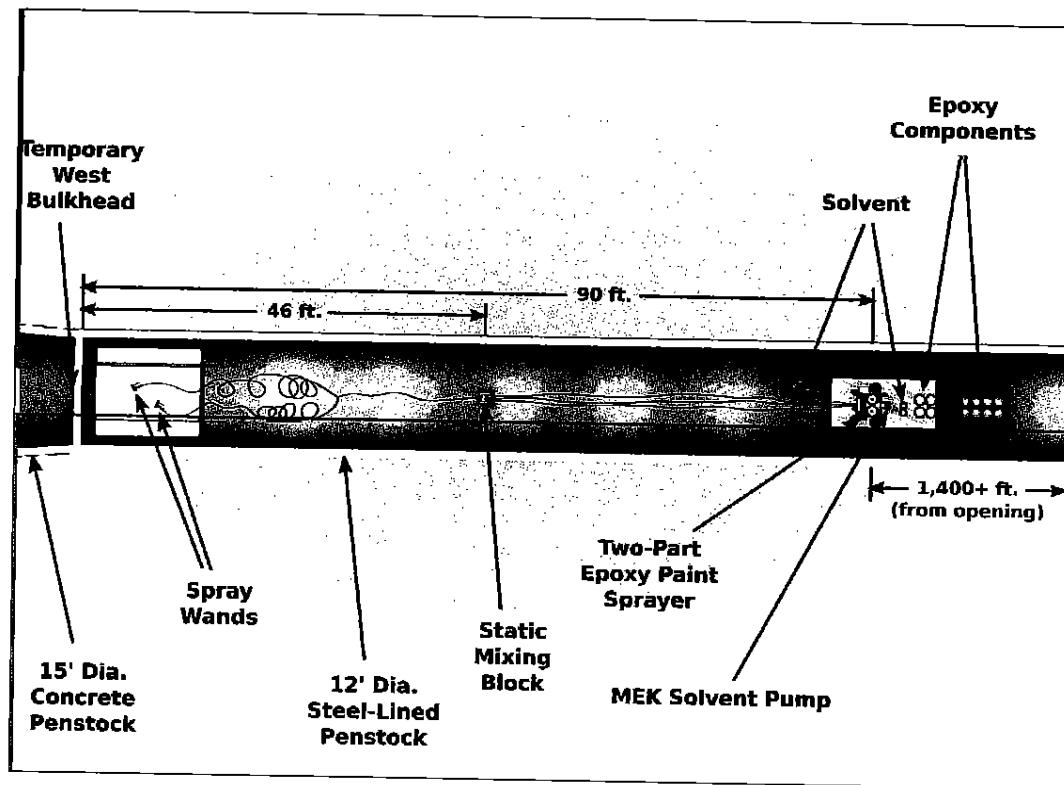
Figure 6. Aerial view of equipment arrangement in work area of the penstock

The sprayer was positioned in the penstock on wheeled scaffolding, which the RPI crew called the “stage,” about 1,400 feet from the access door and approximately 90 feet from the west bulkhead (Figure 6). The controls for the sprayer faced the west bulkhead, so that when a contractor was in position to manipulate the controls, he was looking in the direction of the access door, with the sprayer between him and that single point of egress.

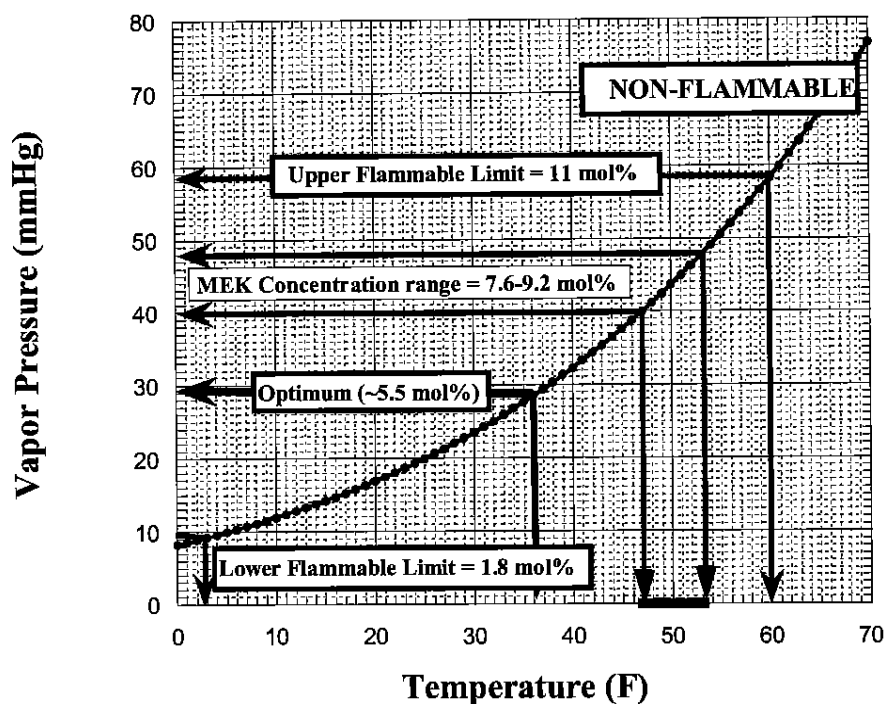
Figure E- 1 Equilibrium vapor pressure of MEK near liquid surface in base hopper

At 523 mmHg, the vapor-liquid equilibrium curve (Figure E-1) shows that the lower and upper flammable limits of MEK in air (1.8-11 volume percent) are attained at respective equilibrium temperatures of 3 to 60 °F (-16 to 15 °C). Between these temperatures, MEK vapor in equilibrium with liquid, such as deep inside the liquid hoppers on the sprayer, is ignitable. MEK vapor becomes most easily ignitable at an “optimum” concentration of about 5.5 volume percent, attained at an equilibrium temperature of about 36 °F (2.4 °C).

Although the low atmospheric pressure in the penstock (523 mmHg) has negligible effect on the flammable limits, it significantly increases the mole fraction of vapor in air at any given temperature. Consequently the flash point is decreased (Figure E-2). The calculated lower theoretical flash point, temperature limit of flammability (TLF) is -16 °C (3.4 °F). For ignition in the base hopper, this TLF should be more accurate than a measured flash point because of (1) the ambient pressure, and (2) upwards flame propagation, which occurs at lower vapor concentrations than in a standard flash point test apparatus (where flame propagation is downward).

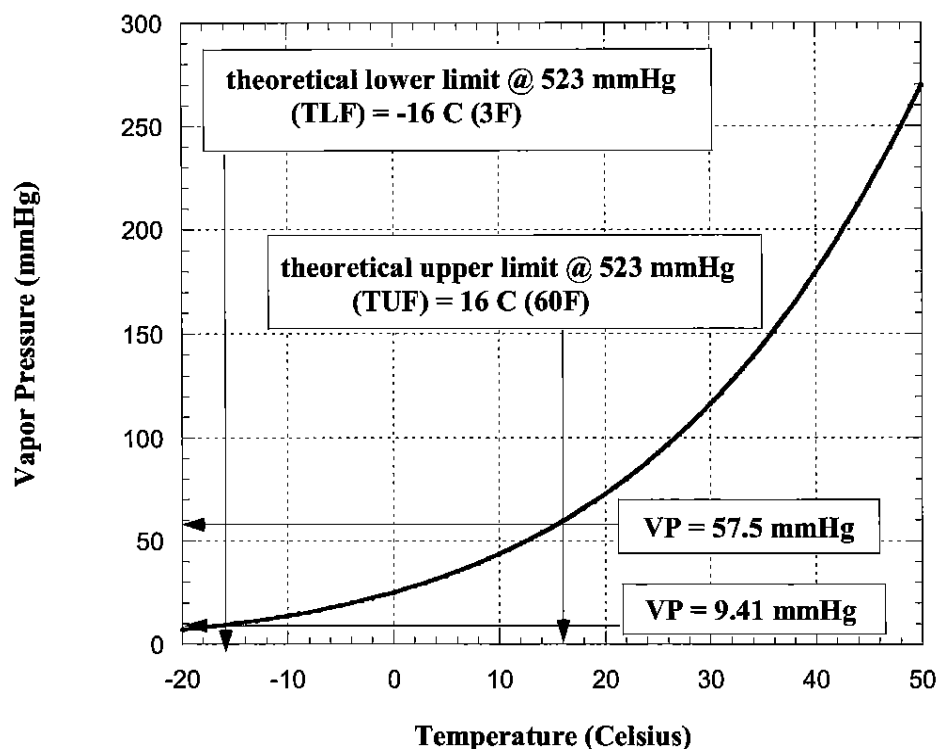
Figure E- 2 Theoretical MEK flammability limits at penstock conditions

Similarly, the “upper temperature limit of flammability” can be calculated. The UFL is generally not sensitive to pressure in the range being considered, so the corresponding MEK vapor pressure is 57.5 mmHg to achieve 11 mole percent MEK in the vapor and the theoretical upper flammability limit (TUF)

is found to be 15 °C (60 °F). This result shows that MEK in the penstock could be within the flammable range (ignitable) at all times inside a pail or hopper.

With the base side pump heater not operating, the CSB determined that the circulated MEK would have been at 50 ± 3 °F (10 ± 2 °C). This range compares favorably with the unheated base resin temperature of 47 °F (8.3 °C) measured by the journeyman painter with a laser temperature indicator, and the air temperature of 53 °F (12 °C) inside the penstock measured earlier that day by the KTA inspector. Hence, near the liquid surface in the bottom of the hopper (i.e., where the vapor-liquid equilibrium assumption is most applicable), the MEK vapor concentration should have been in the range of 7.6-9.1 mole percent.

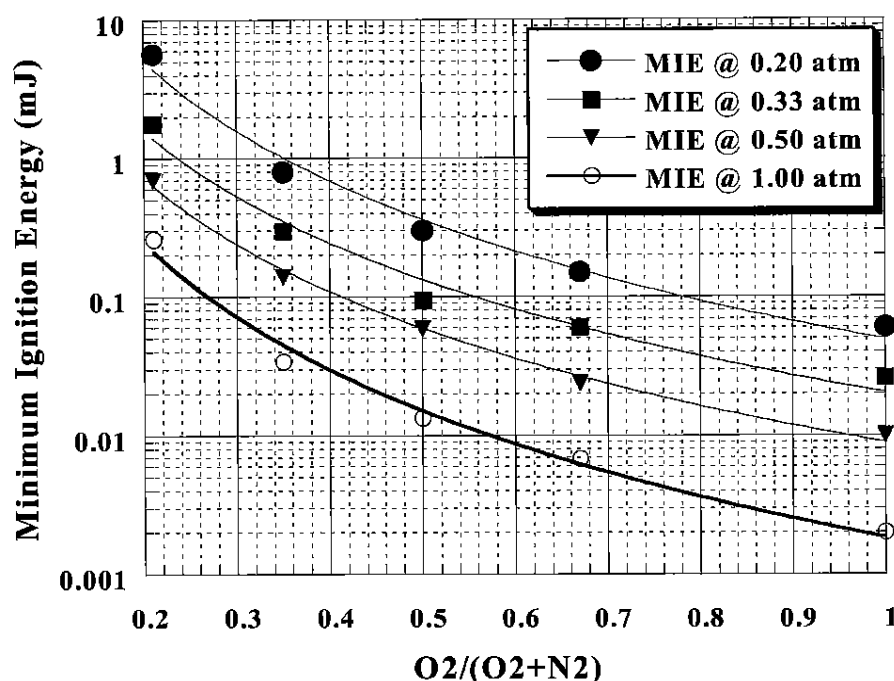
Figure F-1 Effect of pressure on MIE of propane in various oxygen-nitrogen mixtures

However, the LMIE generally increases as pressure decreases. In the penstock, the ambient pressure was about 523 mmHg (0.69 atmospheres). By analogy with data for propane (see Figure F-1), the LMIE of MEK at 0.69 atmospheres (523 mmHg) should be approximately 0.5 mJ. (Britton, 1999):

Hence the lowest MIE for MEK is approximately 0.5 mJ (5.50 mole percent MEK in dry air at 298 K, 0.69 atm).
