# Retired & Dangerous Out-of-Service Equipment Hazards

By Robert Wasileski

#### IN BRIEF

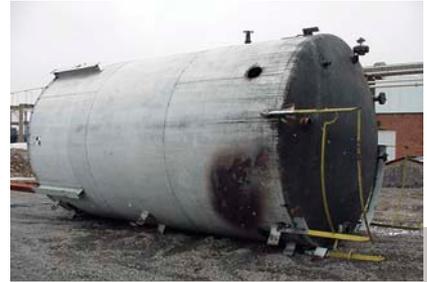
Photo 1 (above): Atmospheric storage tank following the fire.

During the process of removing the first nozzle with the cutting torch, a fire developed inside the tank (Photo 1). Attempts to extinguish the fire with handheld fire extinguishers were unsuccessful and a water fog was quickly introduced inside the tank to extinguish the fire. A large mass of solid foam-

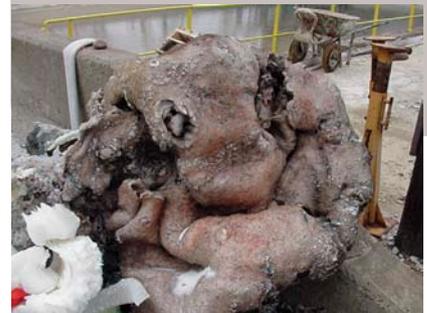
Photo 2: Combustible solid removed from the tank.

like material was later removed from the tank (Photo 2).

As one might suspect, the atmospheric testing that had been performed prior to hot work had not detected this combustible solid inside the tank. However, the presence of such a material was not expected, considering the tank had previously been in flammable liquid service. **During the 15 years that the tank was out of service, an unanticipated hazard had materialized inside the tank and gone unnoticed. The exact mechanism(s) that led to the formation of this foam-like material were never fully understood.** However, one explanation suggested that vinyl benzene monomer had been unintentionally introduced into the tank previously. A slow, uncontrolled polymerization of this monomer in the presence of cyclopentane created the amorphous foam-like combustible material discovered following the fire.

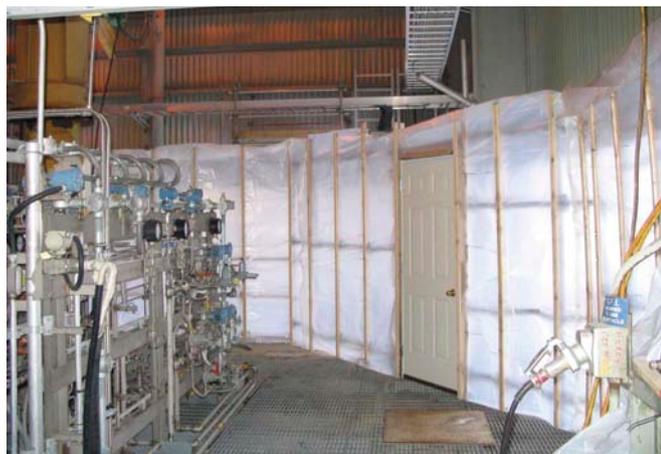
Photo 3 (above): Congestions and confinement created by equipment/buildings.

An additional concern related to vapor cloud explosion hazards arises when OOSE remains installed in a plant (i.e., it is not dismantled). Equipment such as pumps, piping, vessels, tanks and buildings can add unnecessary congestion and confinement to plant layouts (Photos 3 and 4). These physical obstacles can have a significant adverse impact on vapor cloud dispersion and flame-front speeds, particularly with materials that are susceptible to deflagration-to-detonation transition behavior (e.g., hydrogen, acetylene, ethylene).

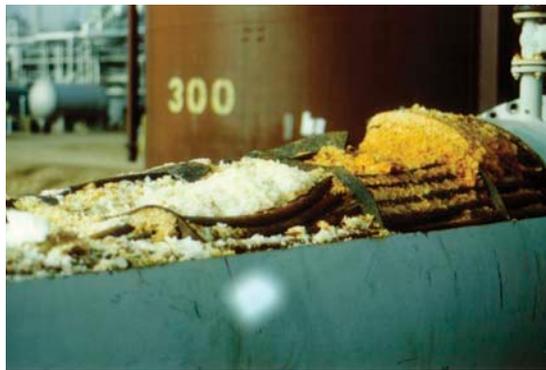
Photo 5: Popcorn polymer formation.

In 1992, an olefins facility experienced an unplanned polymerization of butadiene inside an abandoned overhead condenser. The investigation concluded that oxygen (i.e., air) had inadvertently entered the system, allowing the formation of butadiene peroxides. Over several months, so-called popcorn polymer (Photo 5) slowly formed inside the condenser until a mechanical deformation of the shell occurred due to the high internal pressures created by the polymerization reaction (Photo 6). It is common to observe ruptured piping, exchangers, valves and other equipment following these polymerization incidents due to the high pressures that are generated.

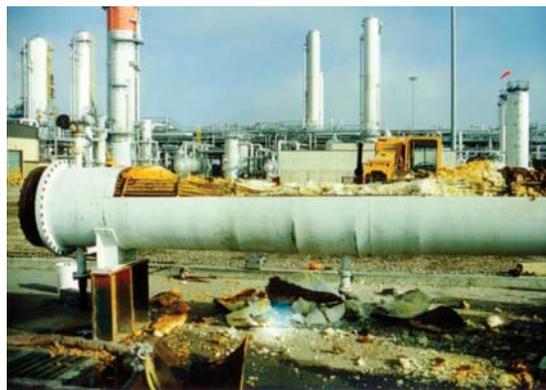
Photo 6: Deformed condenser shell.

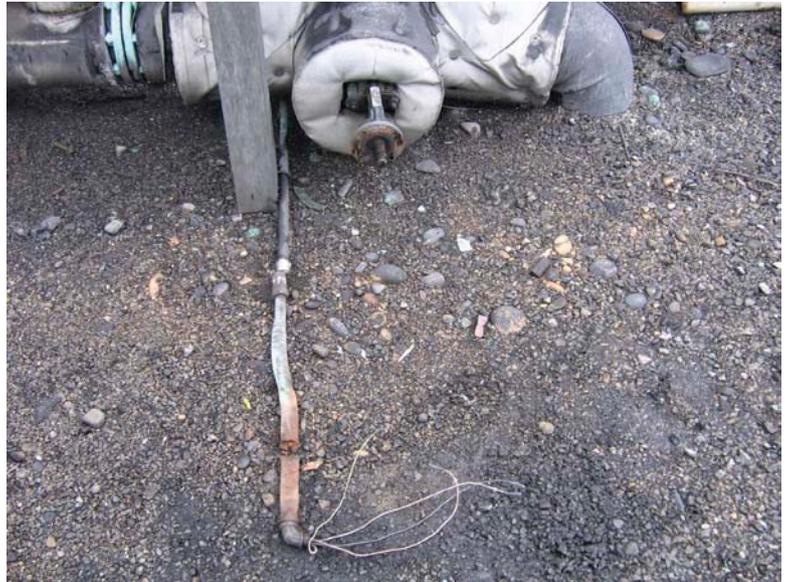
Photo 7 (top): Conduit and valve following the incident.

The actuator had been removed from a motor-operated control valve. The valve body and electrical leads to the actuator were left intact (Photo 7). Over several years, the flexible conduit and leads were gradually buried by the soil and gravel in the area, eventually becoming hidden from sight.

A maintenance employee drove an engine-powered scissor lift into the area to perform unrelated work. When the wheels of the scissor lift passed over the flexible conduit, the conduit and wires were severed and an electrical arc flash occurred (Photo 8). Fortunately, no injuries or property damages occurred, and the system was promptly decommissioned following the incident.

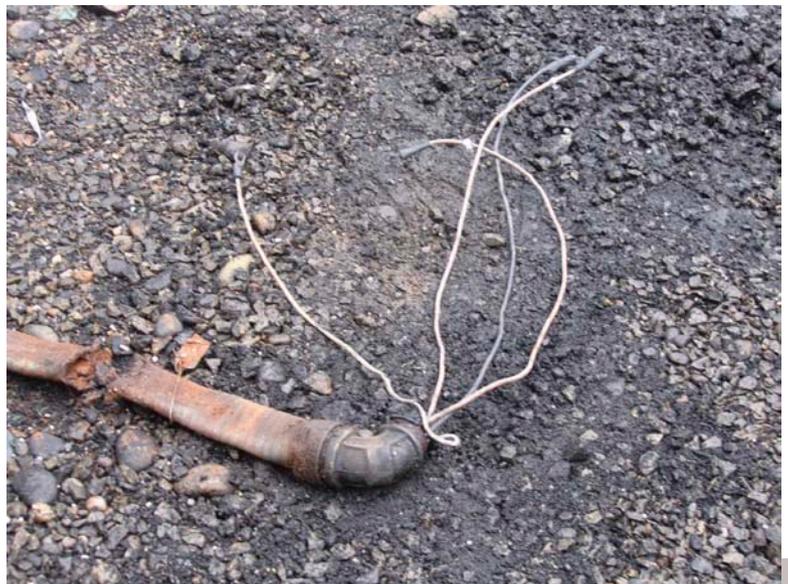
Photo 8: Severed flexible conduit.

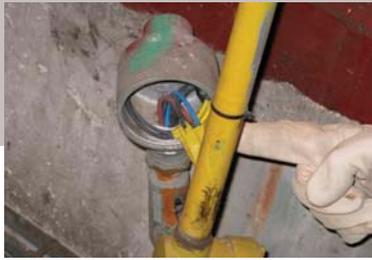
Photos 9 and 10:  
Routes of entry for  
flammable vapors  
and gases into  
electrical conduit.

Unsecured cover plates and open junction boxes (Photos 9 and 10, p. 38) provide an entry point into conduit for gases and vapors. Incidents have occurred where flammables traveled through long conduit runs and were ignited by energized electrical equipment.

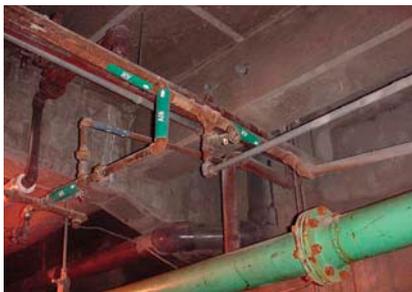
Photo 11 (top):  
Plant air piping in  
utilities building.

Maintenance personnel were dismantling out-of-service piping equipment inside a utilities building. Over several weeks, they had routinely dismantled piping throughout the building, as time permitted. On the day of the incident, a section of small-bore plant air piping was scheduled to be removed using a portable electric band saw (Photo 11). A second line, which was not labeled, was loosely attached to the plant air line with steel wire for support. The second line was about 40-ft long and physically disconnected on both ends.

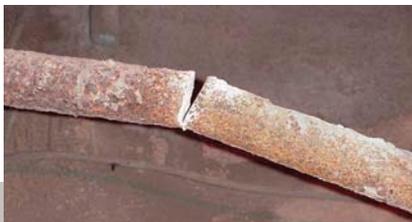
Photo 12: Piping  
containing  
sulfuric acid.

Prior to cutting the lines, maintenance personnel removed pipe hangers to allow the ends of both lines to slope toward the floor. There was no indication of liquid in the piping, as nothing had spilled from the ends and the lines were disconnected from other piping in the area. Shortly after making a cut into the second steel line, liquid began to spray from the pipe (Photo 12). Work stopped immediately, and an investigation was initiated.

The investigation concluded that the liquid was sulfuric acid from a system that had been (partially) decommissioned and out of service for nearly 25 years. Apparently, the acid had been trapped inside the piping by foreign material plugging off the pipe ends.

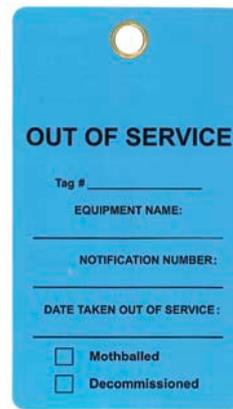
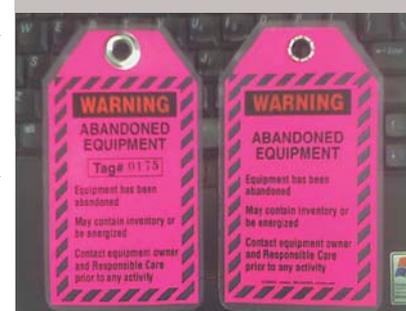
Photos 13 and 14: Examples of out-of-service-equipment tags.

An organized, deliberate effort to identify OOSE in the field is a necessary first step toward incident prevention. Including experienced operating staff in this effort is strongly recommended, as their knowledge and history with the plant will assist in this pursuit. OOSE must be identified as such, and it is generally recommended that a unique, weather-resistant tag be securely affixed to the equipment.

The tags raise awareness of the potential risks to maintenance and contract employees who may be required to work on the equipment in the future. As such, flanges, pipe unions, manway covers and other common line-break locations are logical attachment points for tags. Furthermore, the tags should include a unique alphanumeric identification system that will allow the OOSE inventory to be catalogued in a database. Suitable examples of OOSE tags have been included for illustration purposes (Photos 13 and 14).
