U.S. CHEMICAL SAFETY AND HAZARD INVESTIGATION BOARD

INVESTIGATION REPORT

XCEL ENERGY HYDROELECTRIC PLANT

PENSTOCK FIRE

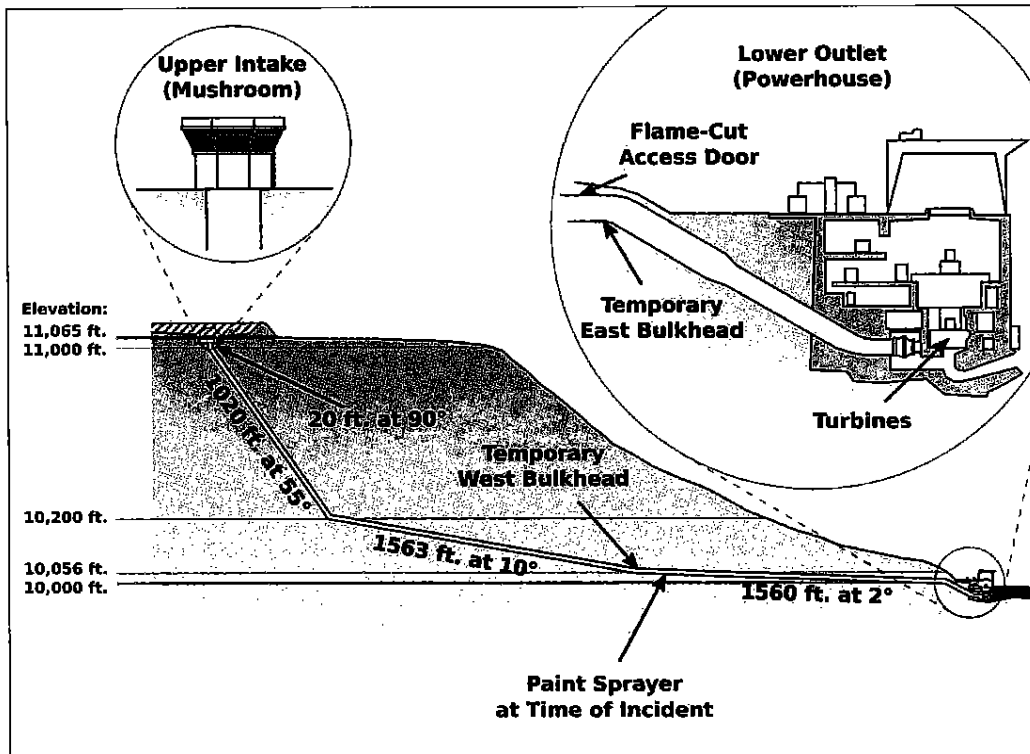
Figure 2. Penstock Configuration

The penstock is 4,163 feet (1,269 meters) long from the upper reservoir's intake to the point at which the penstock splits into two pipes to feed the turbines in the powerhouse. Of this space, 3,123 feet (950 meters) can be traveled by foot. The RPI contractors were hired to recoat roughly one-half of this relatively horizontal space (1,560 feet, or 475 meters, at a 2 degree incline). This section of the penstock is 12 feet (3.7 meters) in diameter, welded, and steel-lined. The remaining portions of the penstock going up into the mountain vary in length and degree of gradient, with the 55 degree section too steep to

traverse (Figure 2). The last 1,040 feet (317 meters) of the penstock requires climbing aids, ropes, or ladder structures to be traversed.
